# ORBITA TECHNOLOGY CO., LTD TEST REPORT

EN 1634-1:2014+A1:2018 TESTING ON HOTEL LOCK, MODEL E3064P AND S3063P IN SINGLE LEAF SINGLE ACTION TIMBER COMPOSITE FIRE DOOR

221115007SHF-001

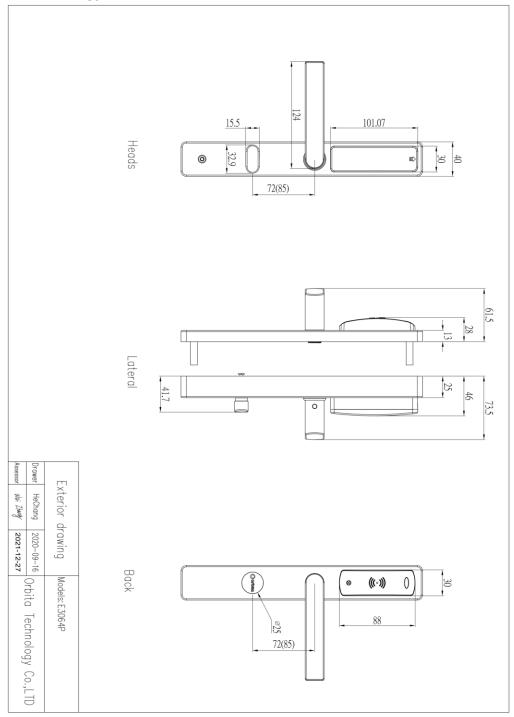
Dimension drawing of Hotel Lock, model E3064P

Documents and samples of two types of Hotel Lock including Model E3064P and S3063P were checked, and found that these Hotel Locks have same design, same function and similar cut-out holes size. Mortise lock, model 4585 is used for these two Hotel locks. The main difference between them is shape of escutcheon, Model E3064P with integrated escutcheons is selected to test to cover Model S3063P with separate escutcheons.

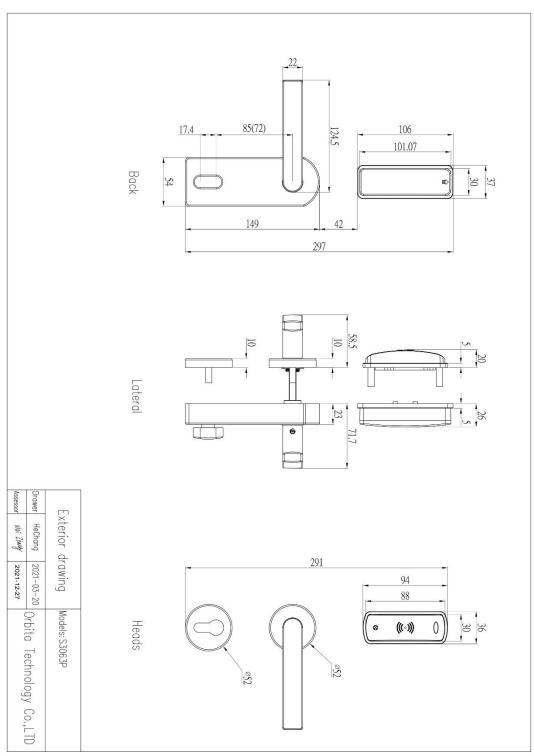
Dimension drawing of Hotel Lock, model S3063P

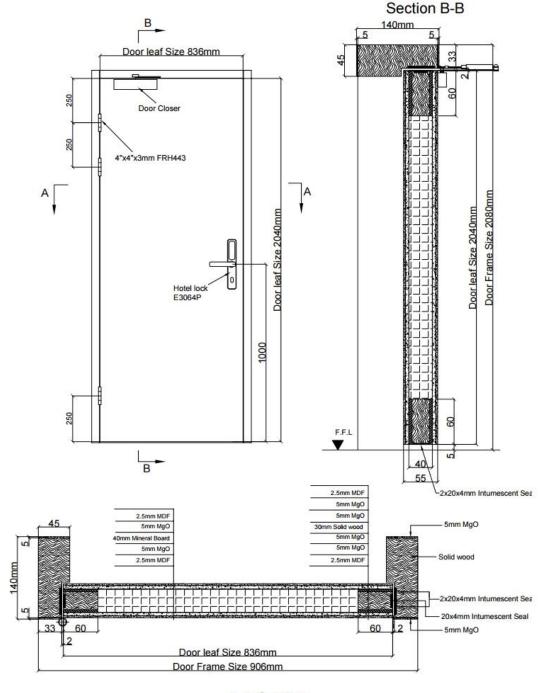
A-A Section

## FIRE DOOR ASSEMBLY DRAWING

TESTED ASS	TESTED ASSEMBLY DESCRIPTION								
	Туре	Single Leaf Single Action Swing Timber Composite Fire Door							
	Nominal Size	836 mm wide by 2040 mm high by 55 mm thick							
		Facing: 2.5 mm MDF, density of 816 kg/m <sup>3</sup>							
Door		Sub-facing: 5 mm Magnesium oxide board, density of 1339 kg/m <sup>3</sup>							
	Main Material	Core: 40 mm Mineral board, density of 452 kg/m <sup>3</sup>							
		Rail: 60 mm x 30 mm solid wood, density of 731 kg/m <sup>3</sup>							
		Stile: 60 mm x 30 mm solid wood, density of 731 kg/m <sup>3</sup>							
	Nominal Size	906 mm wide by 2080 mm high by 140 mm deep							
Frame	Material	Solid wood, density of 731 kg/m³, clad with 5 mm Magnesium oxide board, density of 1339 kg/m³ on both sides							
Hardware	Hotel Lock, Model E3064P	Mortise lock, model 4585 Lock case size: 170 mm x 74 mm x 15 mm Backset: 45 mm; Latch throw: 12 mm Latch bolt: engaged; Deadbolt: disengaged.  Front escutcheon: Panel material: 2.0 mm Stainless Steel Size: L280 mm x W40 mm x D13 mm (without induction panel) Induction panel: ABS Back escutcheon: Panel material: 1.5 mm Stainless Steel

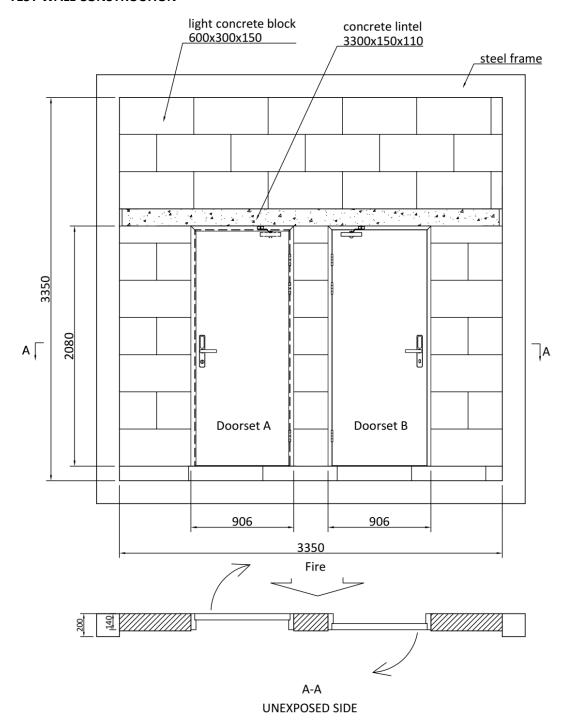
## **TEST WALL CONSTRUCTION**

The test assembly was installed in a steel restraint frame. The test doorsets were built into a concrete masonry unit partition, with fully mortared joints. The test assembly placed in front of the furnace for the fire exposure. Prior to the commencement of the EN 1634-1 fire test, the test doorsets to be test were checked for operability in the fire test frame by operating from fully closed to fully open, for 25 cycles. The test measurement data was shown in Section 9.

The nominal dimensions of the test wall were 3 m high by 3 m wide.

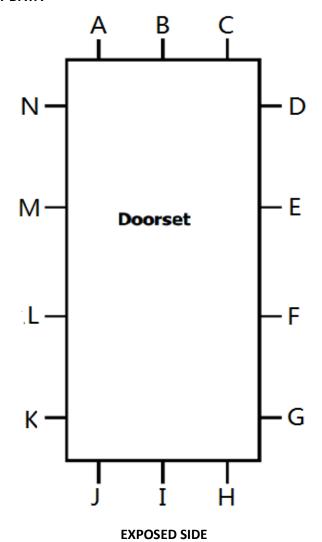
Clear	Clearance dimension in mm at each position of Doorset A												
Α	A B C D E F G H I J K L M N												
1.0	1.0 1.9 1.5 0.2 0.1 1.0 2.8 8.9 9.0 7.9 0.3 0.6 1.1 2.9

## **DOOR ASSEMBLY INITIAL CLEARANCES**

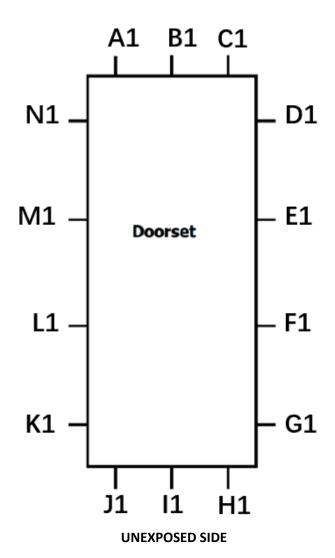
Clear	Clearance dimension in mm at each position of Doorset B												
A1	A1 B1 C1 D1 E1 F1 G1 H1 I1 J1 K1 L1 M1 N1												
1.2	2.0	2.4	0.1	0.1	8.0	2.6	7.2	9.0	9.0	1.8	0.1	1.4	3.0

# **DOOR ASSEMBLY INITIAL CLEARANCES**

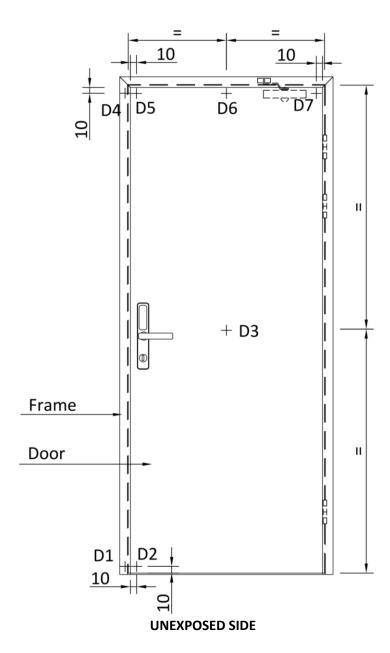
POSITION FOR MEASUREMENT OF HORIZONTAL DEFLECTION OF DOORSET A

# Horizontal Deflection of Doorset A (Positive values indicate movement into the furnace)

Time Mins	D1 (mm)	D2 (mm)	D3 (mm)	D4 (mm)	D5 (mm)	D6 (mm)	D7 (mm)
0	0	0	0	0	0	0	0
10	0	-1	6	2	2	5	4
20	0	-1	14	3	6	11	13
30	-1	1	12	10	15	17	23
40	-1	1	15	11	17	21	26
50	-1	-1	32	11	16	27	31
60	-1	-1	47	13	18	37	35
68	-1	0	62	14	18	52	39

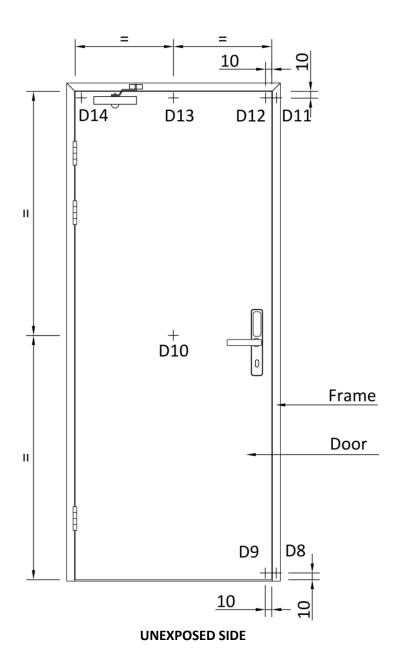
POSITION FOR MEASUREMENT OF HORIZONTAL DEFLECTION OF DOORSET B

# Horizontal Deflection of Doorset B (Positive values indicate movement into the furnace)

Time Mins	D8 (mm)	D9 (mm)	D10 (mm)	D11 (mm)	D12 (mm)	D13 (mm)	D14 (mm)
0	0	0	0	0	0	0	0
10	-1	-5	1	2	0	2	/
20	0	-3	6	6	7	7	12
30	-1	-2	7	11	15	18	23
40	0	4	9	14	18	22	26
50	1	4	15	16	20	26	31
60	2	4	33	17	23	30	31
68	2	-22	38	22	23	34	31

Note: "/" means the measurement of the deflection was invalid due to the heavy smoke.

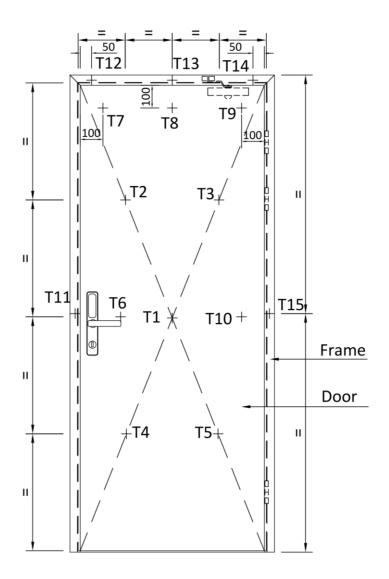
## POSITION FOR MEASUREMENT OF UNEXPOSED TEMPERATURE OF DOORSET A

# Unexposed surface temperatures of Doorset A

Time Mins	T1 (°C)	T2 (°C)	T3 (°C)	T4 (°C)	T5 (°C)	Mean Temperature (°C)
0	10	9	9	8	8	9
3	10	9	9	9	8	9
6	10	9	9	8	8	9
9	11	9	9	9	9	9
12	11	10	9	9	9	10
15	12	11	11	10	11	11
18	14	14	13	13	13	13
21	17	18	17	17	17	17
24	21	22	21	21	21	21
27	25	27	25	26	25	26
30	30	31	30	31	30	30
33	34	36	35	35	34	35
36	38	40	39	40	38	39
39	42	44	43	44	42	43
42	46	48	47	48	46	47
45	49	51	51	52	49	50
48	52	55	54	56	52	54
51	56	58	57	59	55	57
54	59	61	60	63	58	60
57	62	65	64	66	61	64
60	65	68	66	69	64	66
63	68	71	69	72	66	69
66	70	73	72	75	69	72
68	72	75	73	77	70	73

Time	T6	<b>T7</b>	Т8	Т9	T10	T11	T12	T13	T14	T15
Mins	(°C)	(°C)	(°C)	(°C)	(°C)	(°C)	(°C)	(°C)	(°C)	(°C)
0	8	9	9	10	8	8	7	7	8	8
3	9	9	10	16	8	8	8	9	10	9
6	8	9	10	12	8	8	8	10	10	9
9	9	9	10	11	8	8	9	11	12	9
12	9	10	11	12	9	8	9	12	14	9
15	10	12	12	14	10	8	9	12	19	9
18	13	15	16	17	13	8	10	12	18	9
21	17	20	20	21	16	8	10	12	18	9
24	21	25	25	25	21	9	10	12	17	9
27	26	31	30	31	26	9	11	12	17	9
30	31	37	36	36	30	9	11	12	17	9
33	36	42	41	41	35	9	12	12	17	9
36	41	48	45	46	40	9	13	12	17	9
39	45	52	49	51	44	9	14	12	18	10
42	49	57	53	55	48	9	16	13	20	10
45	53	61	57	59	51	10	17	14	21	10
48	57	64	60	62	54	10	19	15	23	11
51	61	68	64	66	58	10	20	16	25	11
54	64	71	67	69	61	11	22	17	26	12
57	67	74	70	72	64	11	24	18	28	12
60	70	77	73	74	67	12	26	20	31	13
63	73	79	75	77	69	12	29	22	32	14
66	76	81	78	82	72	13	31	24	36	15
68	77	82	79	89	73	14	34	27	40	15

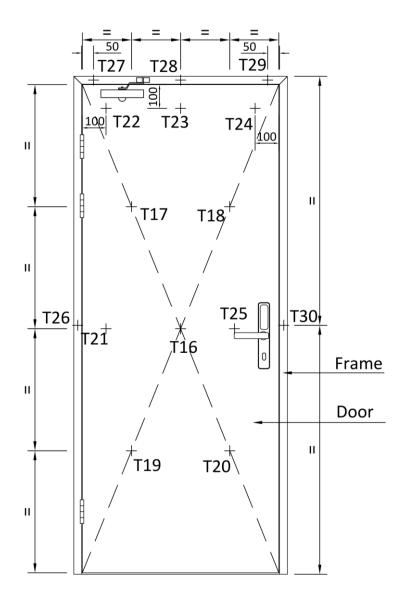
POSITION FOR MEASUREMENT OF UNEXPOSED TEMPERATURE OF DOORSET B

# **Unexposed surface temperatures of Doorset B**

Time Mins	T16 (°C)	T17 (°C)	T18 (°C)	T19 (°C)	T20 (°C)	Mean Temperature (°C)
0	9	10	9	9	9	9
3	10	10	9	10	9	10
6	9	10	9	9	9	9
9	10	10	9	10	9	10
12	10	10	10	10	9	10
15	11	12	11	11	11	11
18	14	15	14	13	13	14
21	18	18	18	17	17	18
24	21	23	22	20	21	21
27	25	27	26	25	25	26
30	30	32	31	29	30	30
33	34	36	35	34	34	35
36	38	41	40	39	39	39
39	42	45	44	43	43	43
42	45	49	47	47	47	47
45	49	52	51	50	51	51
48	52	55	54	54	54	54
51	55	58	57	57	57	57
54	58	61	60	60	61	60
57	60	64	63	62	64	63
60	63	66	65	65	66	65
63	65	69	68	67	69	68
66	68	71	70	70	72	70
68	69	72	71	71	73	71

Time	T21	T22	T23	T24	T25	T26	T27	T28	T29	T30
Mins	(°C)									
0	9	9	9	9	9	8	8	8	8	8
3	9	9	9	9	9	9	11	20	23	8
6	9	11	9	9	9	9	15	21	25	8
9	9	11	9	10	9	9	19	19	37	8
12	9	17	10	10	10	10	28	24	62	8
15	12	16	11	13	11	20	32	25	69	9
18	14	17	14	17	14	20	34	24	54	11
21	17	20	18	22	18	19	35	24	49	15
24	21	23	22	28	22	18	36	24	55	18
27	25	28	27	33	27	18	41	25	59	23
30	29	33	32	38	32	17	47	26	65	27
33	33	39	37	42	37	17	57	27	65	29
36	38	44	42	46	42	18	61	29	63	31
39	42	49	47	50	46	19	65	32	64	33
42	46	54	52	54	50	21	68	34	65	35
45	49	58	56	57	53	22	71	38	64	36
48	53	61	60	60	57	24	74	42	59	38
51	56	65	63	63	60	26	77	47	58	39
54	59	68	67	66	63	29	78	52	58	41
57	62	70	70	69	65	31	80	57	59	43
60	65	72	73	71	68	34	84	66	60	49
63	68	73	75	73	70	37	85	73	63	52
66	70	74	76	75	73	39	88	74	65	57
68	72	76	77	76	74	41	89	74	66	60

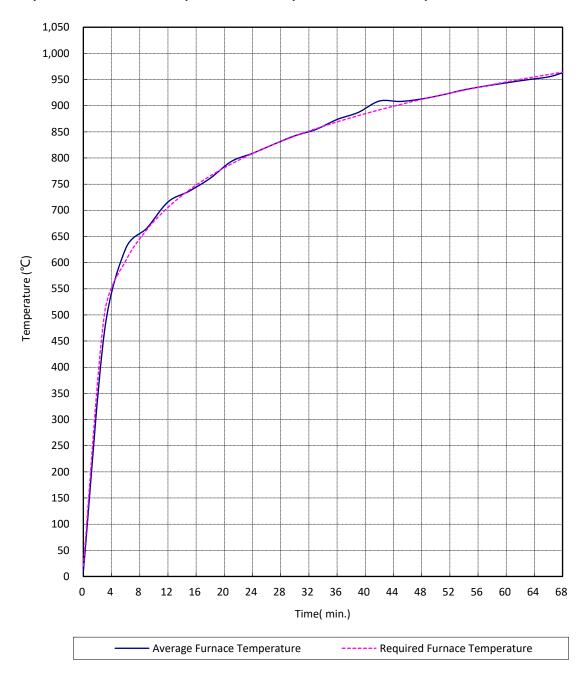
## Graph for mean furnace temperature and temperature-time curve specified in the standard

Time	Specified Furnace	Furnace Mean
Mins	Temperature (°C)	Temperature (°C)
0	20	9
3	502	469
6	603	627
9	663	666
12	705	716
15	739	736
18	766	761
21	789	793
24	809	809
27	826	826
30	842	842
33	856	855
36	869	874
39	881	887
42	892	909
45	902	908
48	912	913
51	921	921
54	930	930
57	938	937
60	945	944
63	953	950
66	960	955
68	964	963

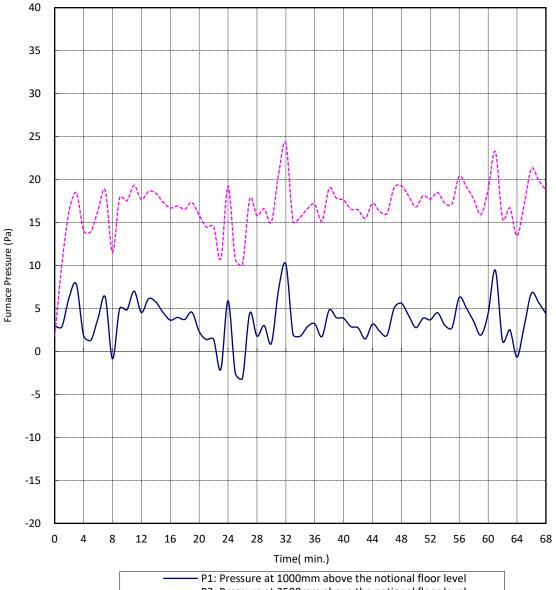
## **Graph of Furnace pressure**

P2: Pressure at 2500mm above the notional floor level

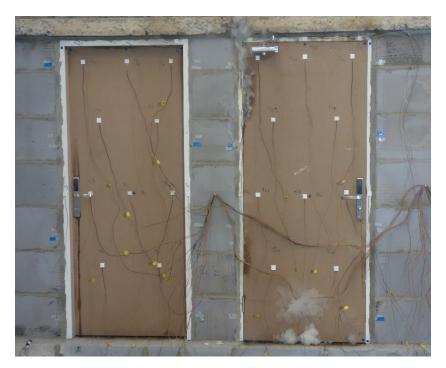
Fig. 3 Unexposed Side after 20 Minutes

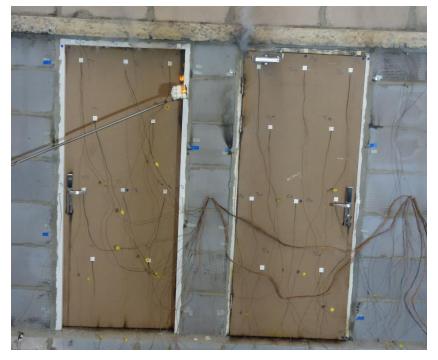
Fig. 4 Cotton pad test on Doorset A at 66 Minutes

After exposed to the fire for a period of 66 minutes, a cotton pad was applied at the top hinge of the door and the pad was ignited. The integrity failure was deemed to occur.

The doorset A therefore met the criteria of the test standards for integrity performance of 66 minutes.

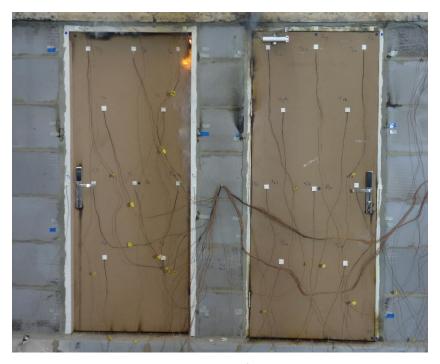
Fig. 5 Unexposed Side after 68 Minutes

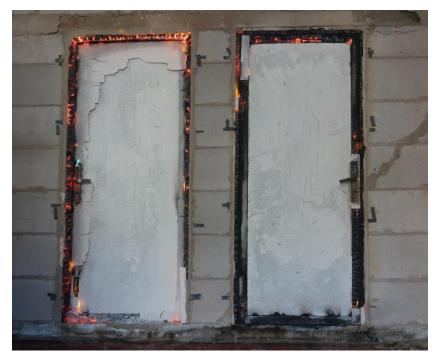
Fig. 6 Exposed Side after 68 Minutes
